Manhole Inspection Summary

Manhole # **S15CC_021MH**

Insp Date: **11/5/07 11:20 AM**

Location Address: **1110 ASHBURTON**

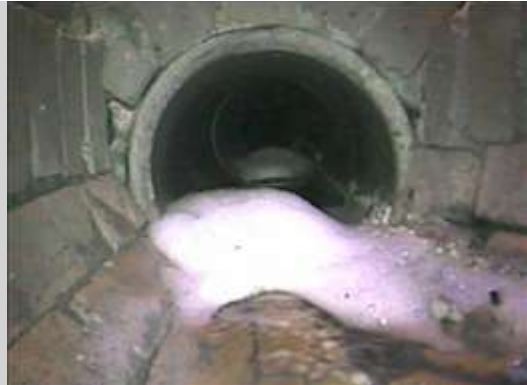
12 O'Clock Outflow

8 in. Circular Gravity Sewer
Pipe Out @ 12 O'Clock

Pipe Height: (in.) Direct
Pipe Material: **Clay** ☐ Pipe Lined
Invert Depth: **7.49** (ft.) Flow Characteristics: **Slow**
Deposits: ☒ None ☐ Mud ☐ Sludge ☐ Debris ☐ Grease
Silt Depth: (in.) Deposits Extent:
Infiltration: **None** Pipe Seal Cond: **Sound**

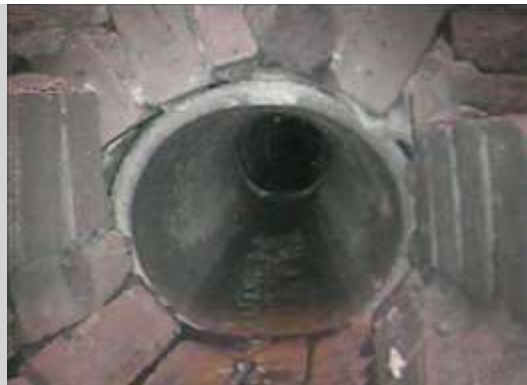
3 O'Clock Inflow

8 in. Circular Gravity Sewer
Pipe In @ 3 O'Clock

Pipe Height: (in.) Direct
Pipe Material: **Clay** ☐ Pipe Lined
Invert Depth: **7.42** (ft.) Flow Characteristics: **Slow**
Deposits: ☒ None ☐ Mud ☐ Sludge ☐ Debris ☐ Grease
Silt Depth: (in.) Deposits Extent:
Infiltration: **None** Pipe Seal Cond: **Sound**

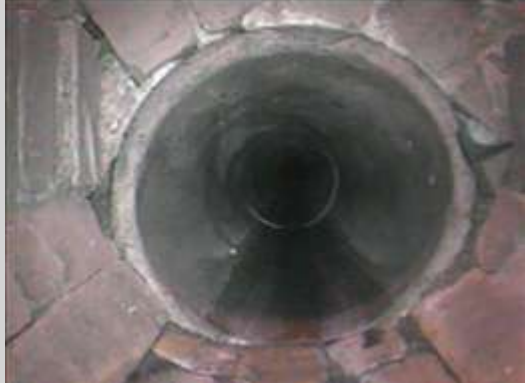
6 O'Clock Inflow

8 in. Circular Gravity Sewer

Pipe In @ 6 O'Clock

Invert Depth: **7.33** (ft.) Flow Characteristics: **Slow**

Infiltration: **None** Pipe Seal Cond: **Sound**
